# *Recovering from the Flood: Building Better by Working with Nature*

**Parks &  
Open Space**

# *Recovering from the Flood*

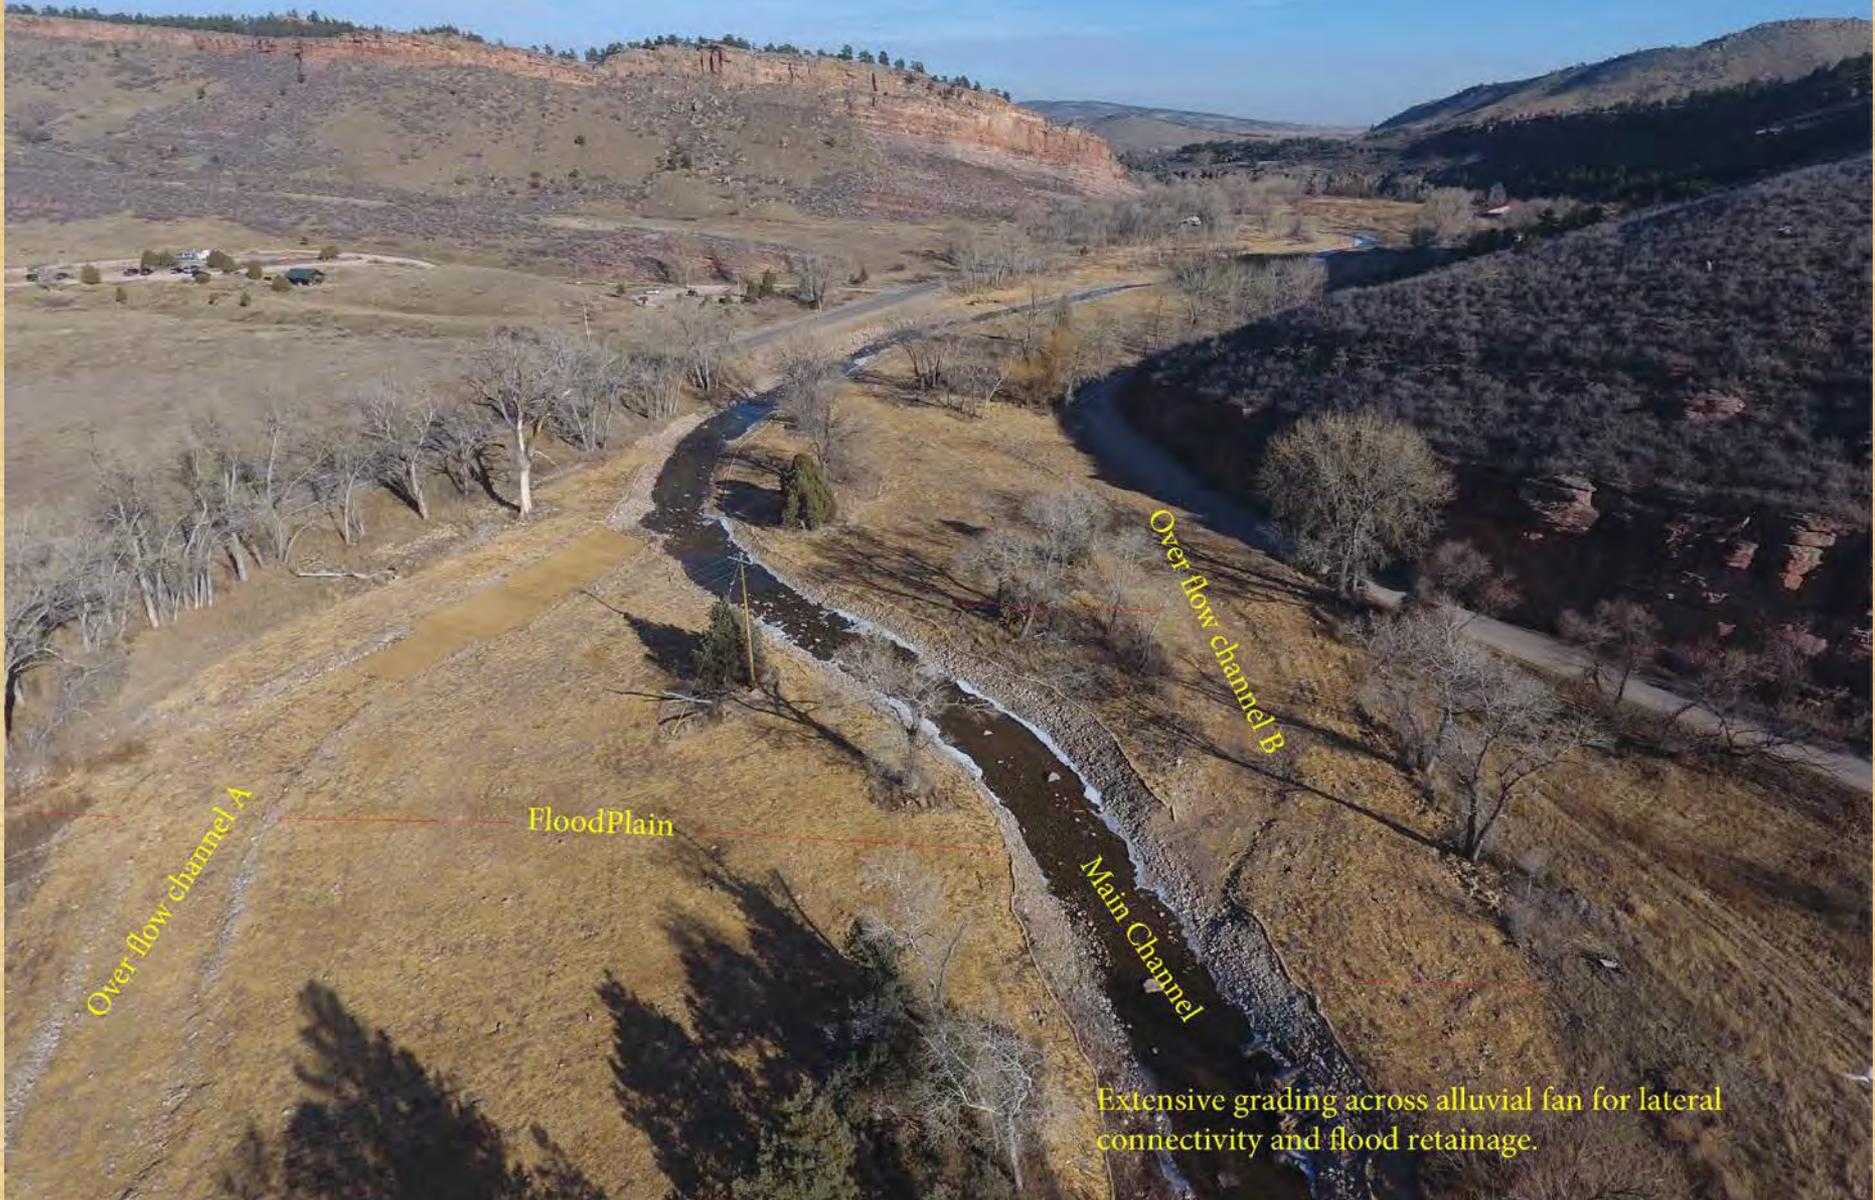
LATERAL CONNECTIVITY

Over flow channel A

Flood Plain

Main Channel

Over flow channel B

Extensive grading across alluvial fan for lateral connectivity and flood retainage.

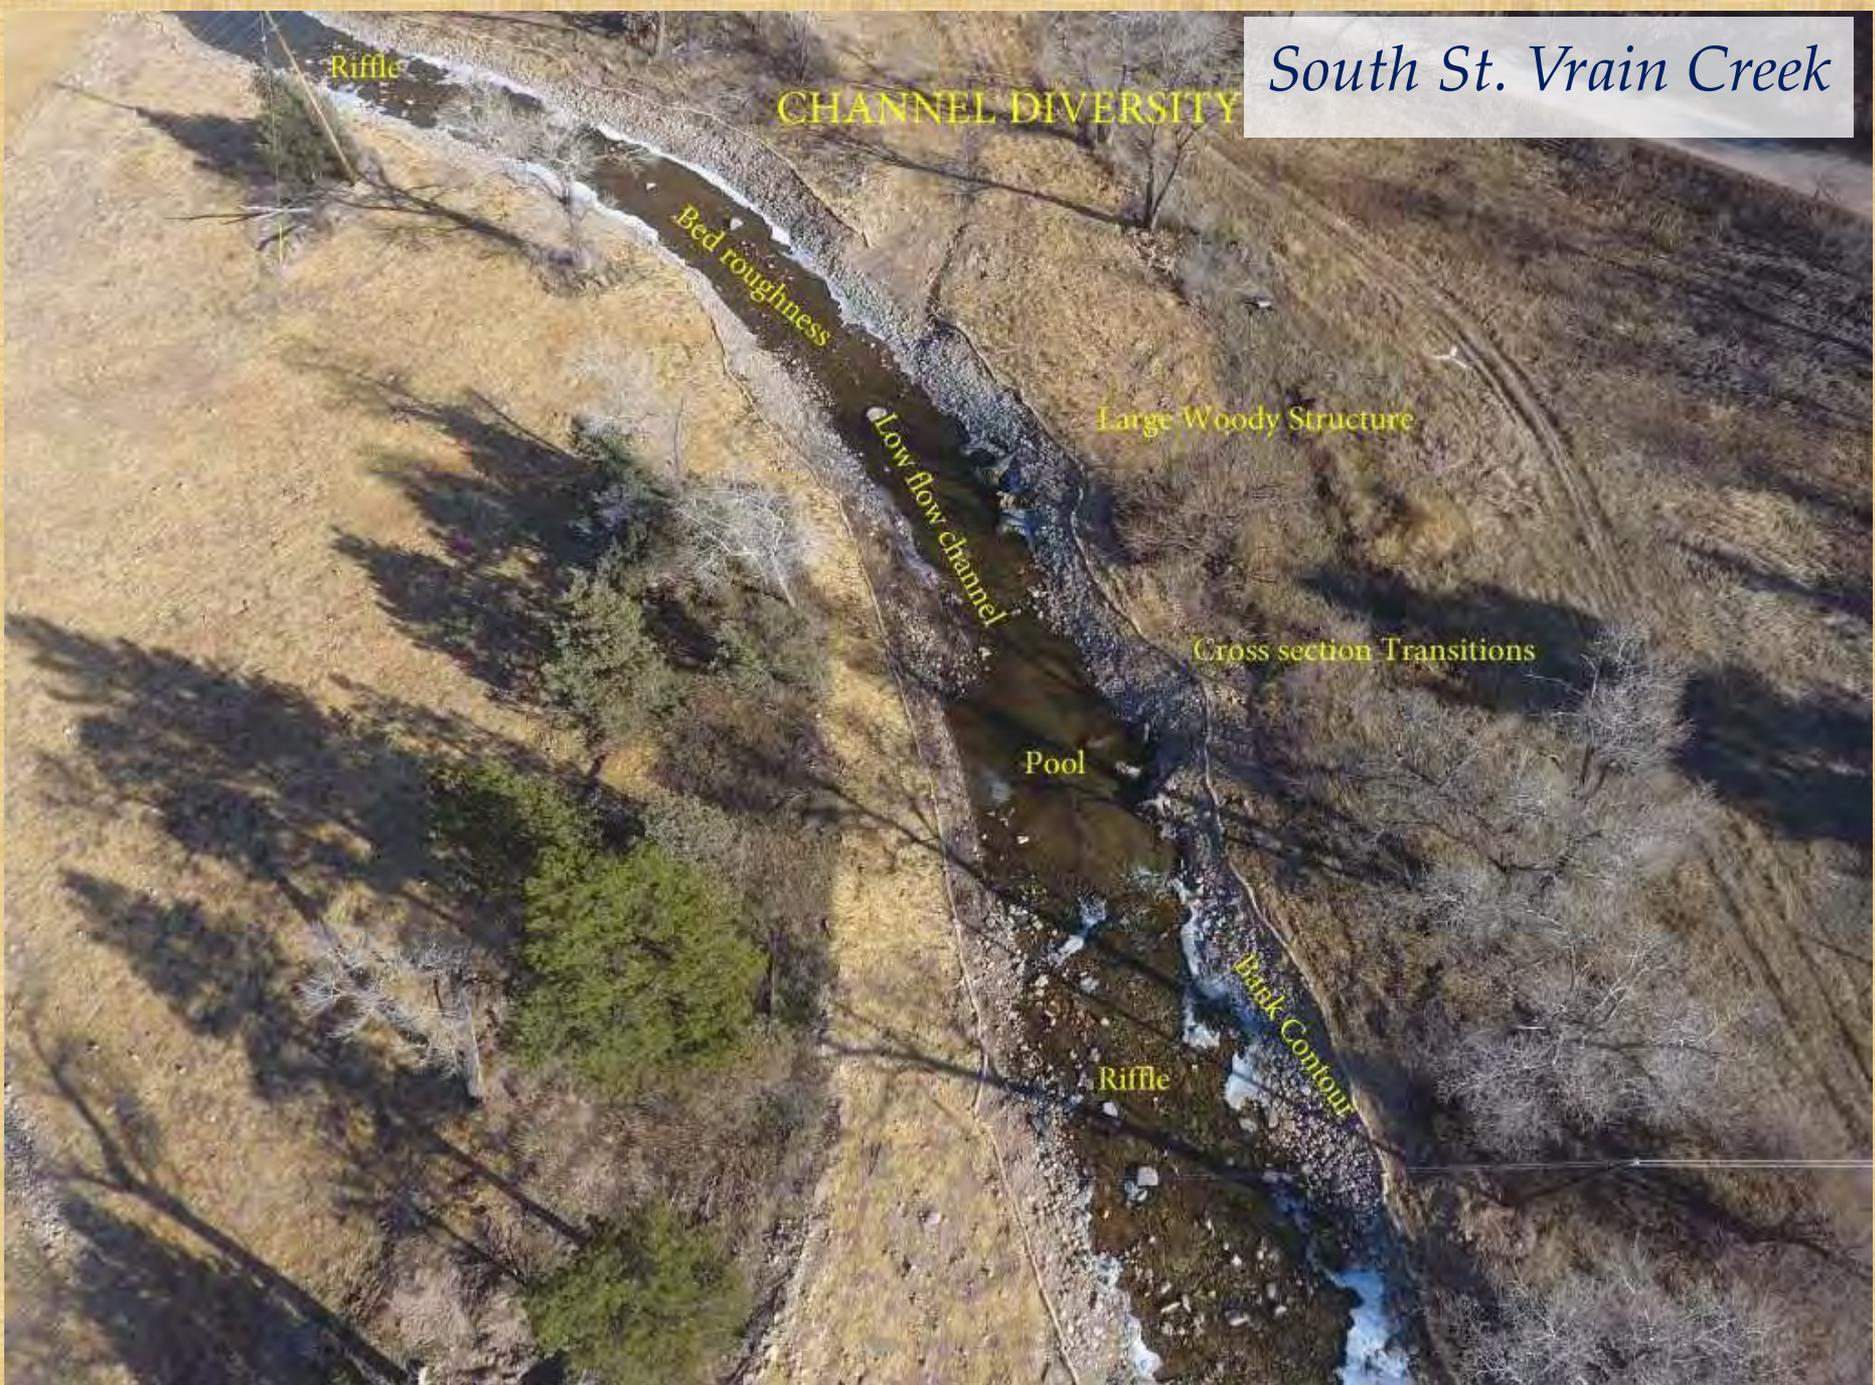
## CHANNEL DIVERSITY

Riffle

Bed roughness

Low flow channel

Large Woody Structure

Cross section Transitions

Pool

Bank Contour

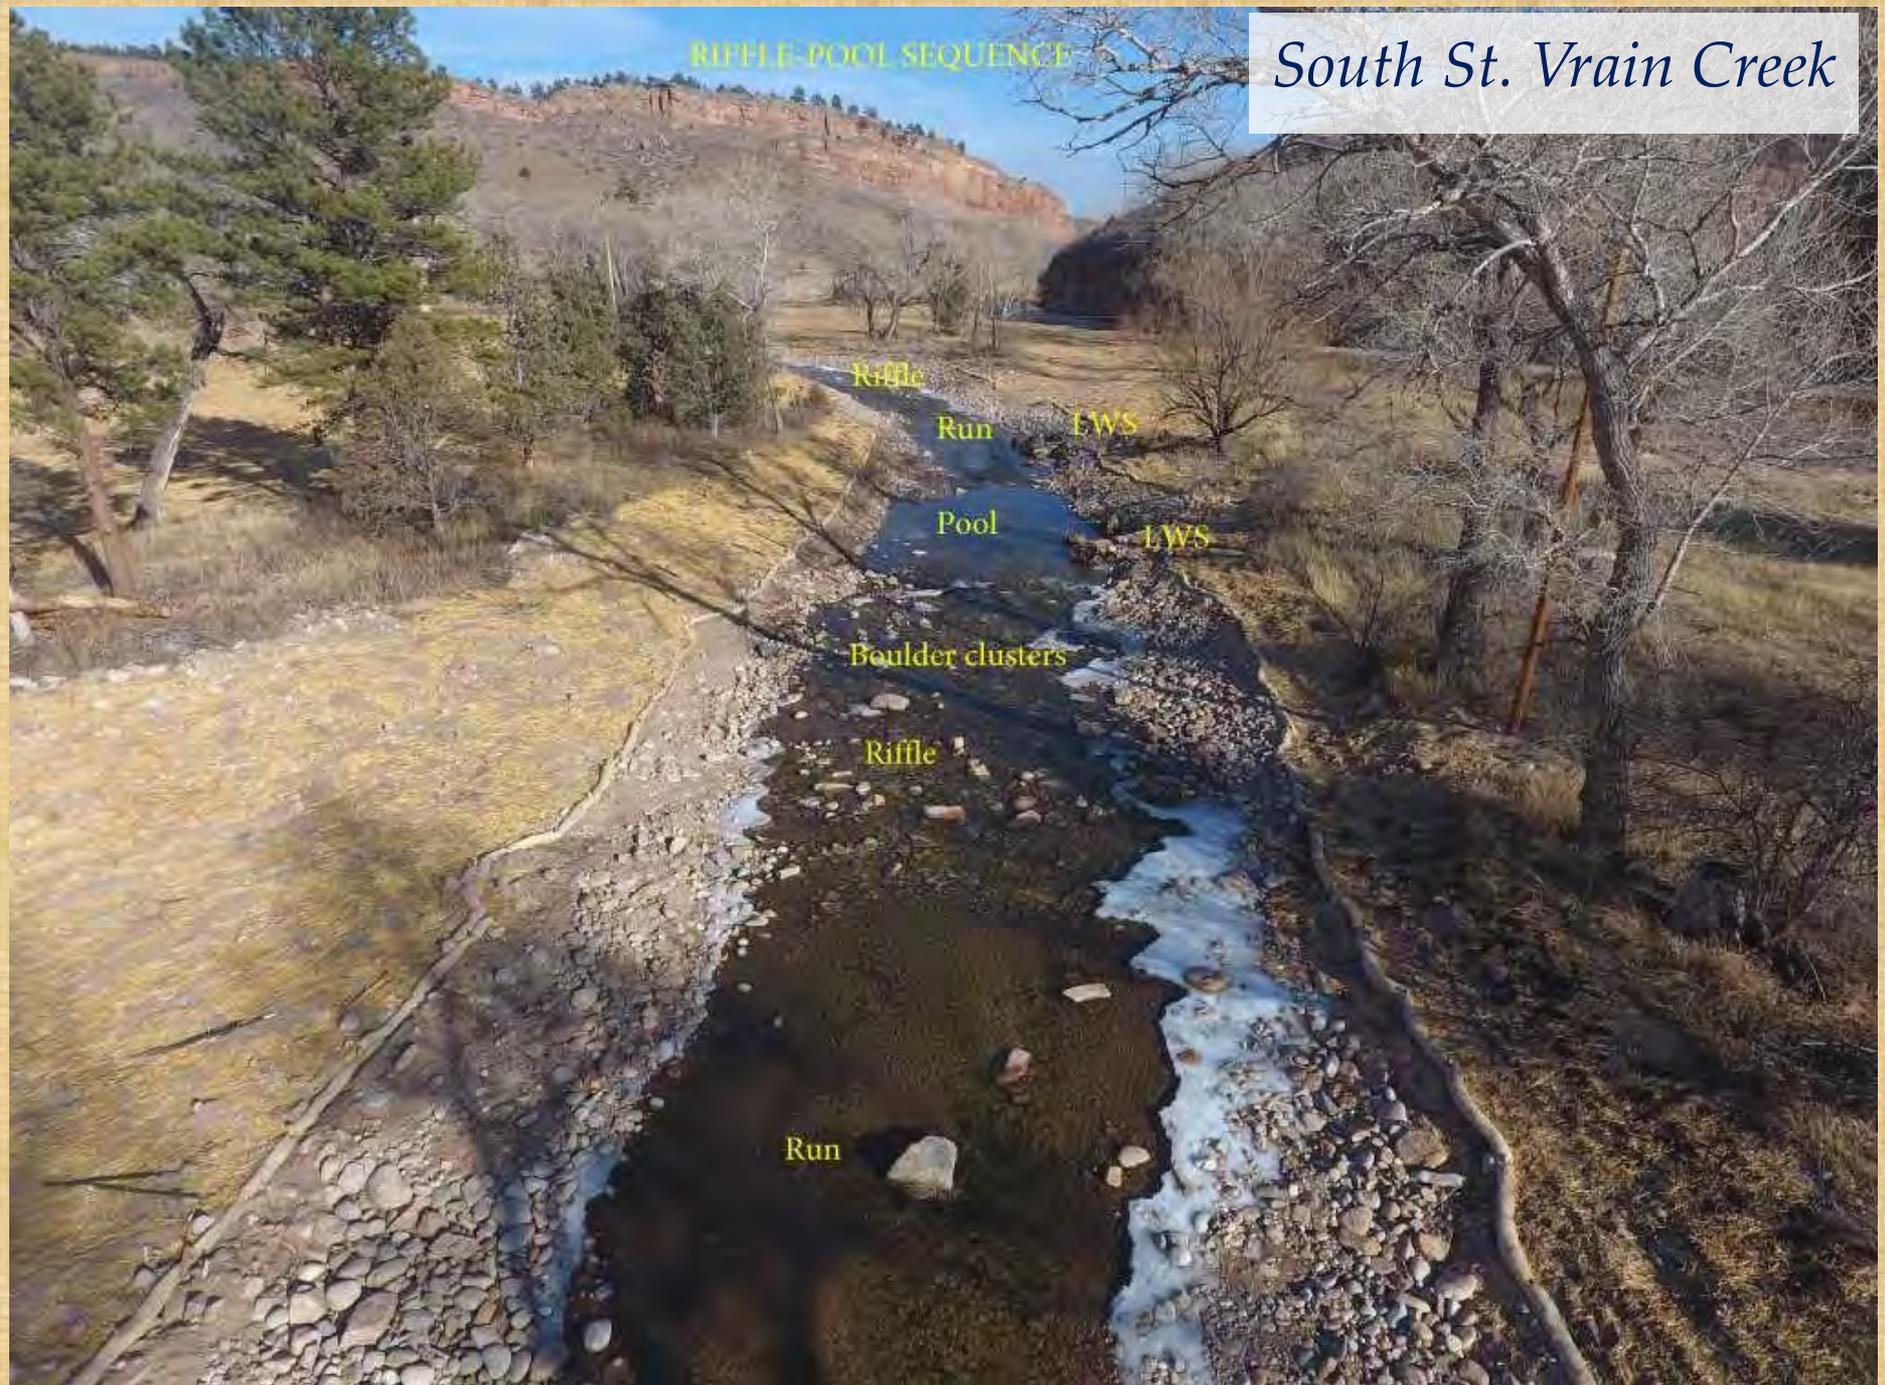
RIFFLE-POOL SEQUENCE

Floodplain

Riffle

Run

Pool

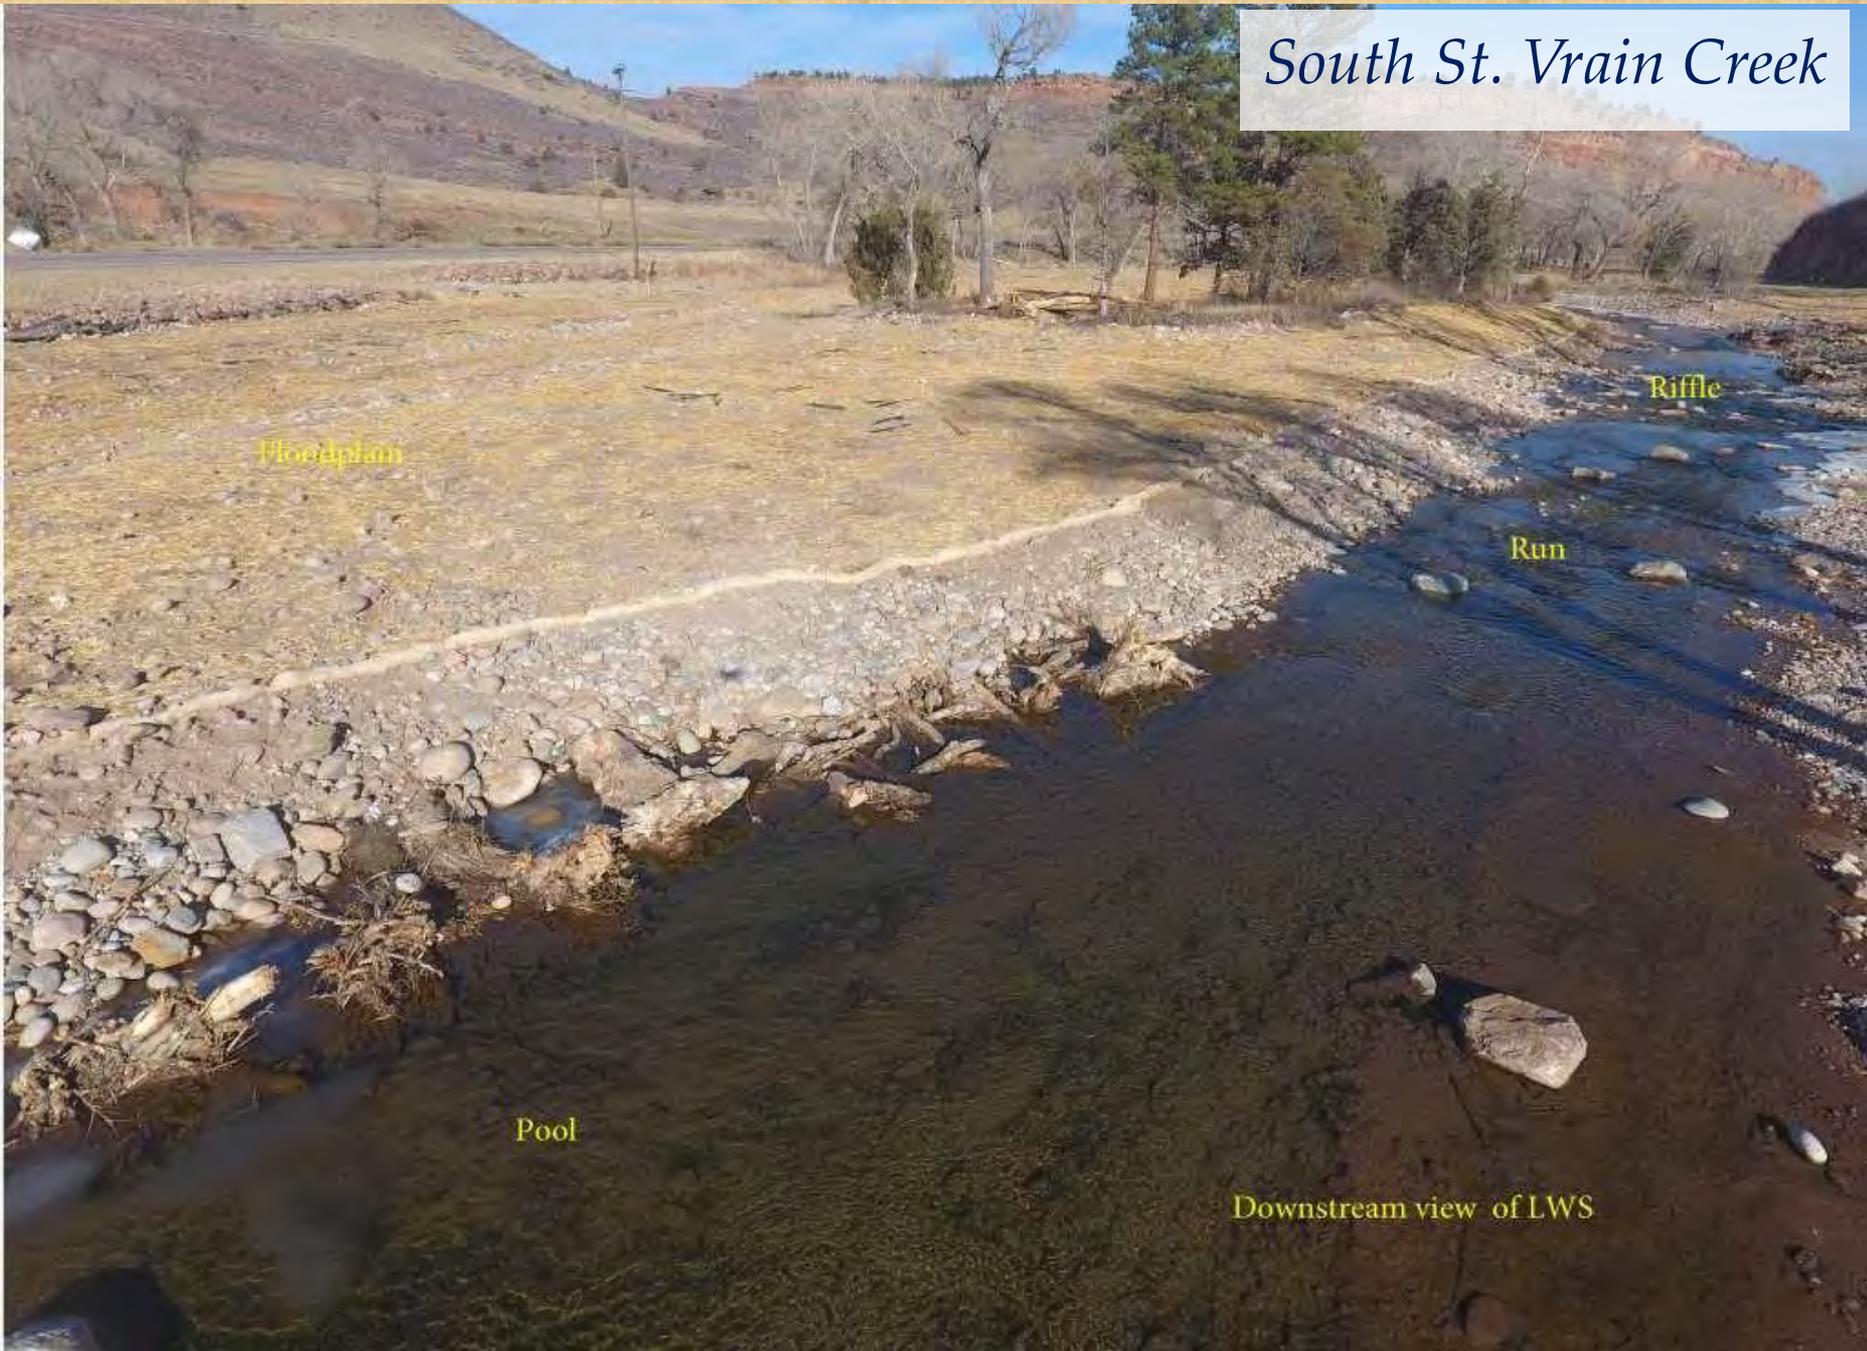
Downstream view of LWS

Large Woody Structure designed for bank protection and habitat values

Each LWS comprises 8-9 specified logs designed individually and configured to act as a cohesive unit at different flow conditions

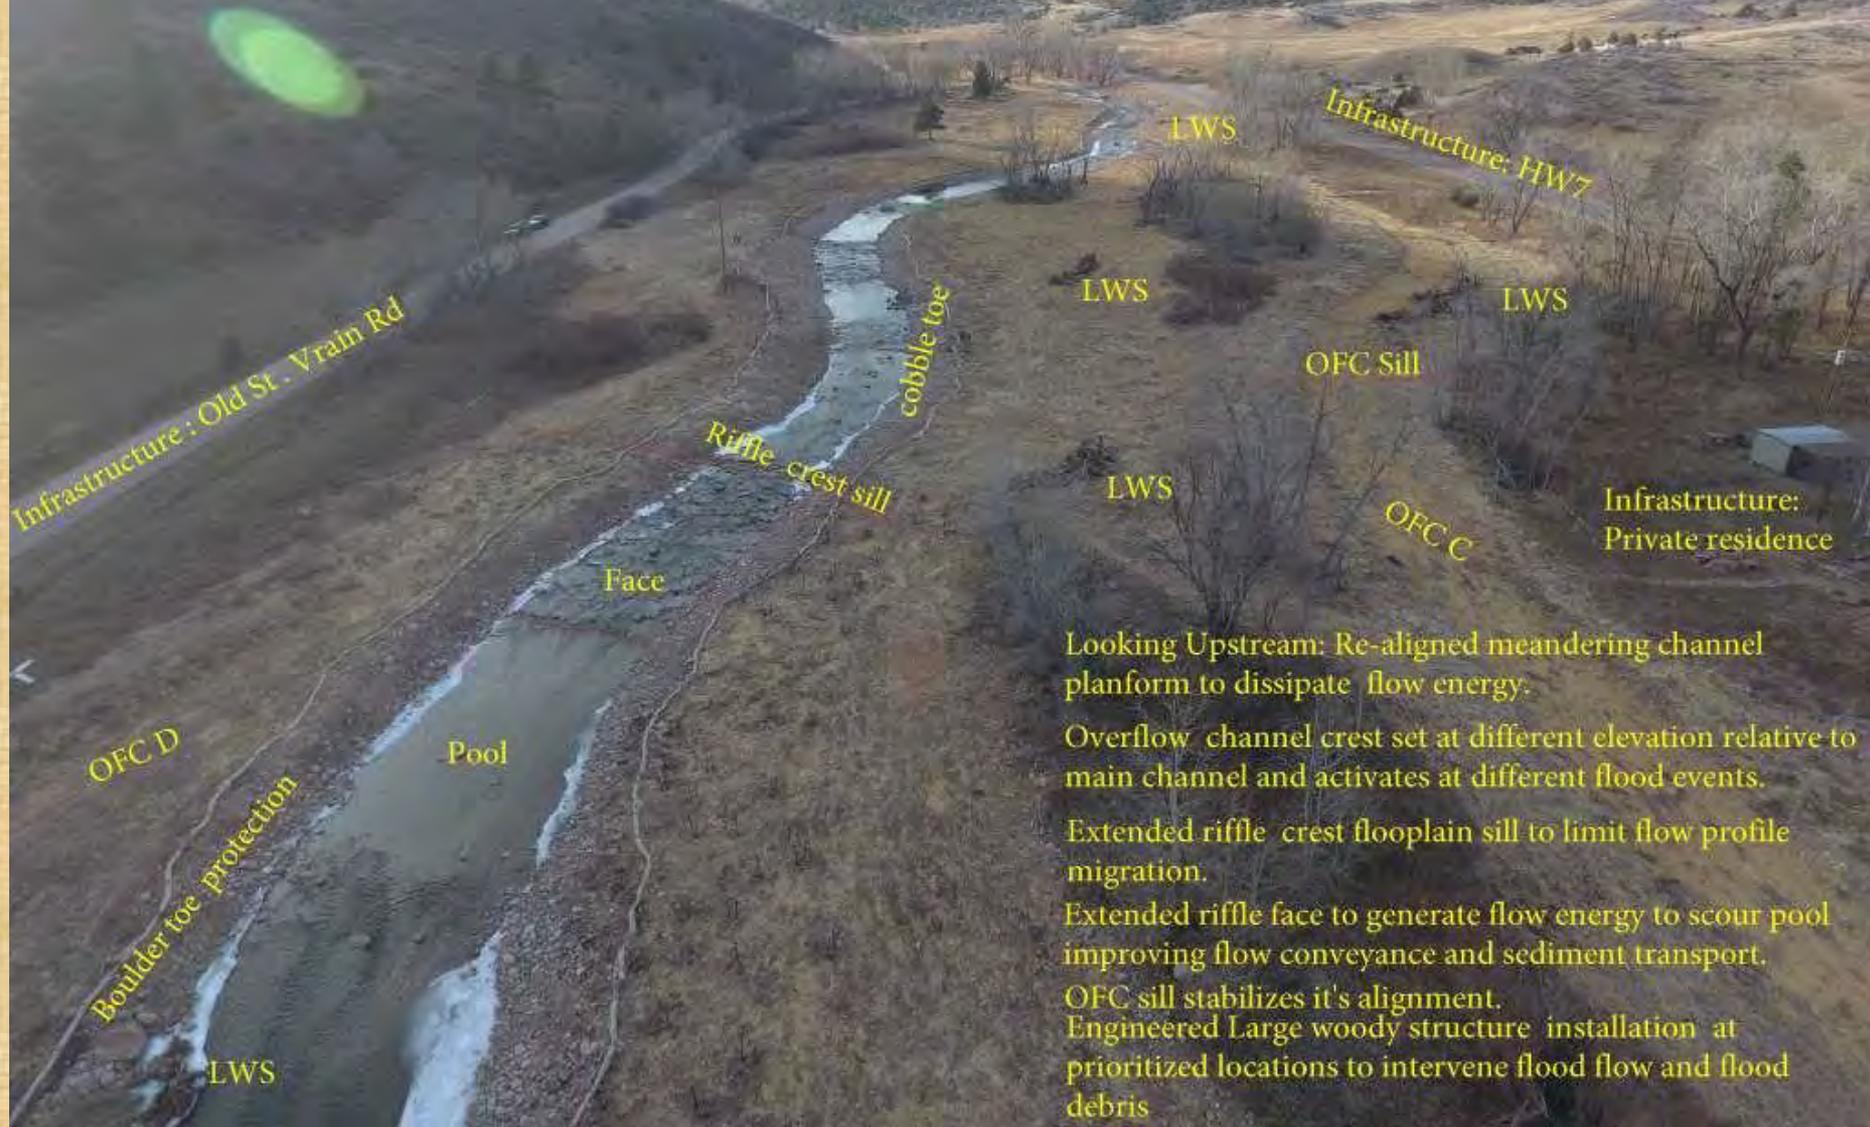
## INFRASTRUCTURE PROTECTION

Looking Upstream: Re-aligned meandering channel planform to dissipate flow energy.

Overflow channel crest set at different elevation relative to main channel and activates at different flood events.

Extended riffle crest floodplain sill to limit flow profile migration.

Extended riffle face to generate flow energy to scour pool improving flow conveyance and sediment transport.

OFC sill stabilizes it's alignment.

Engineered Large woody structure installation at prioritized locations to intervene flood flow and flood debris

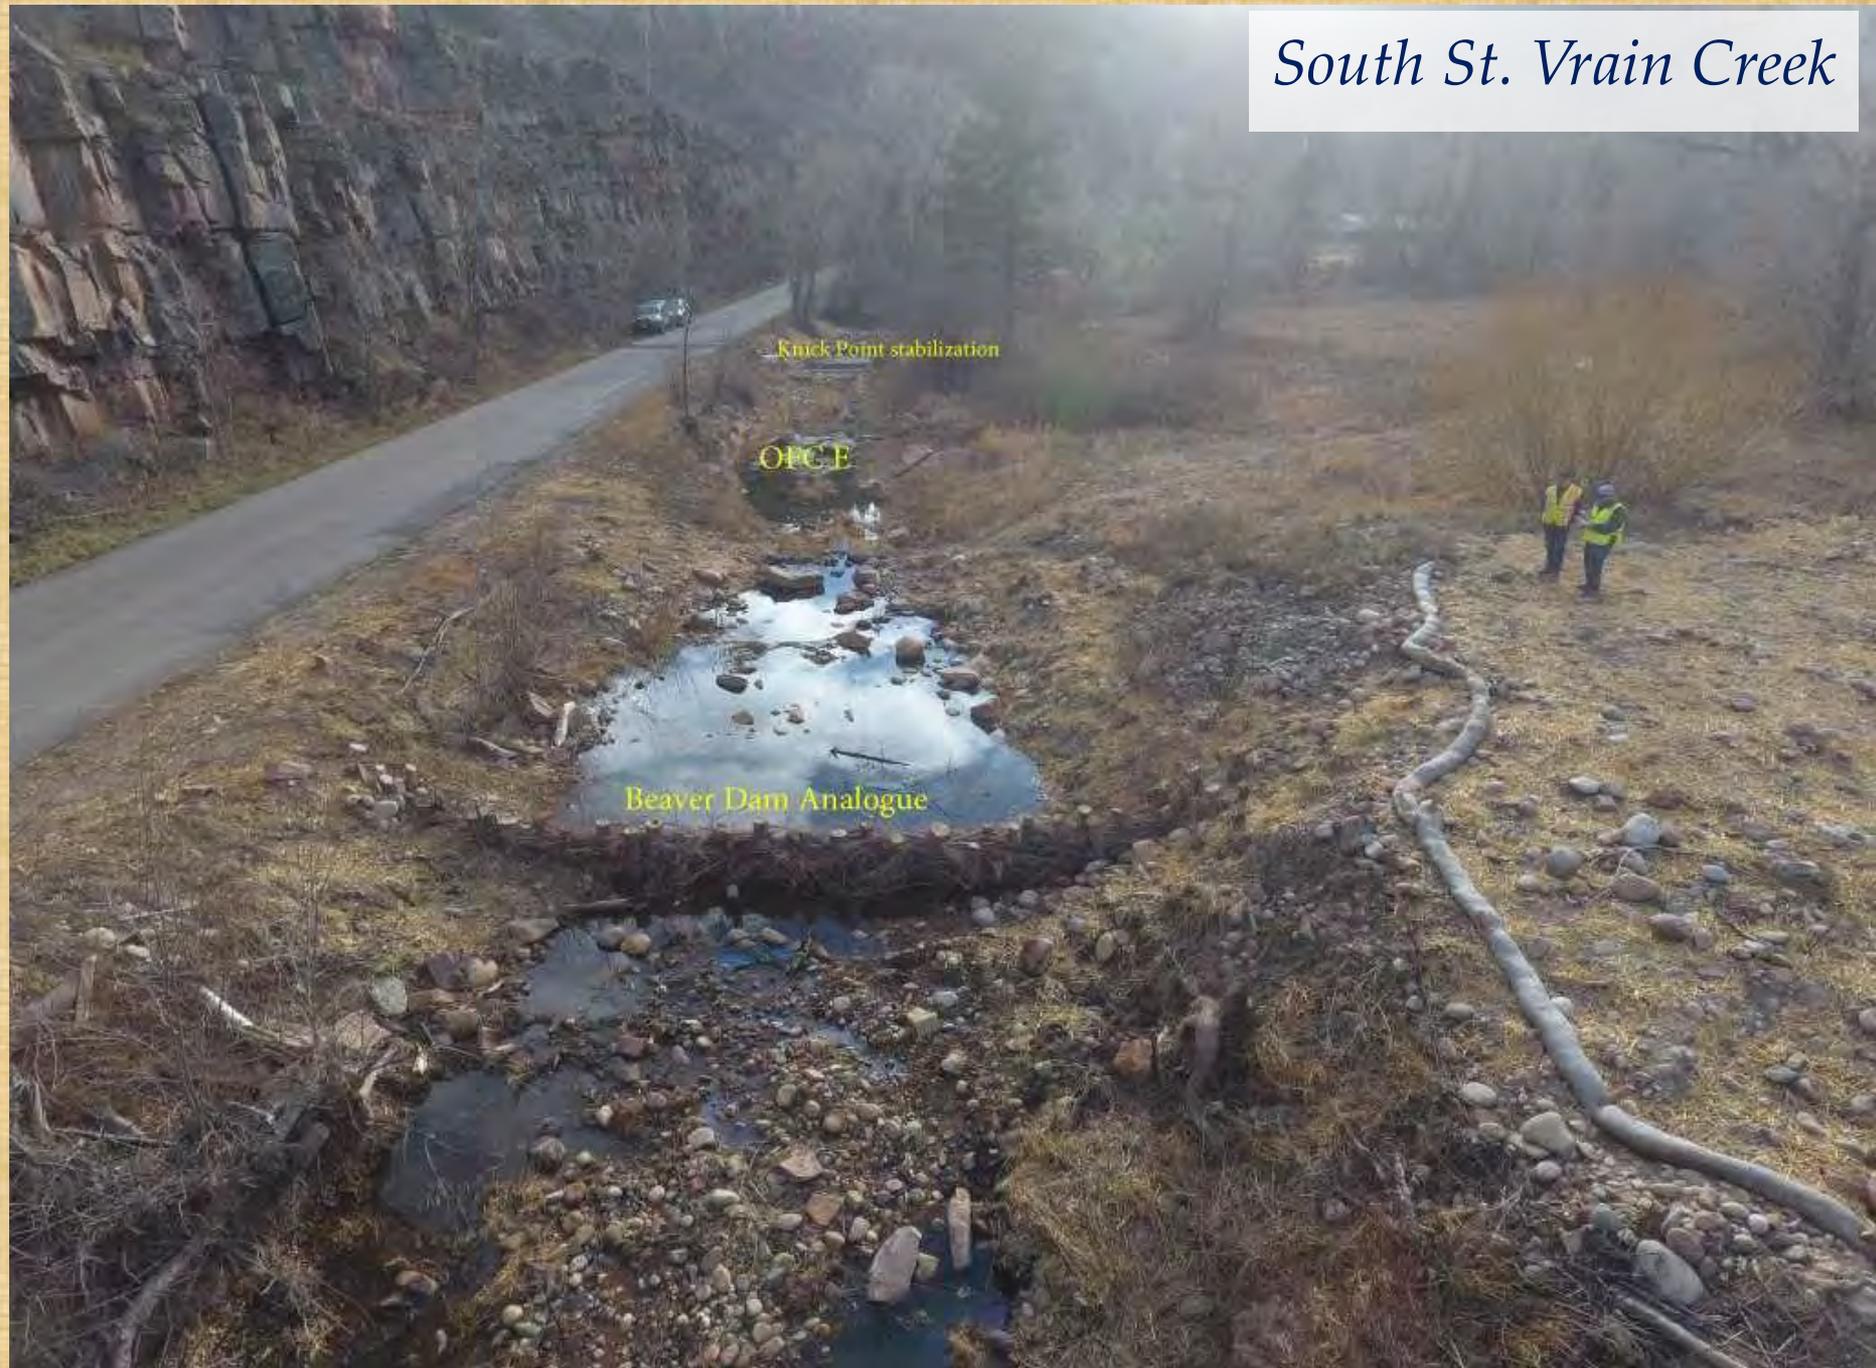
Knick Point stabilization

OFCE

Beaver Dam Analogue

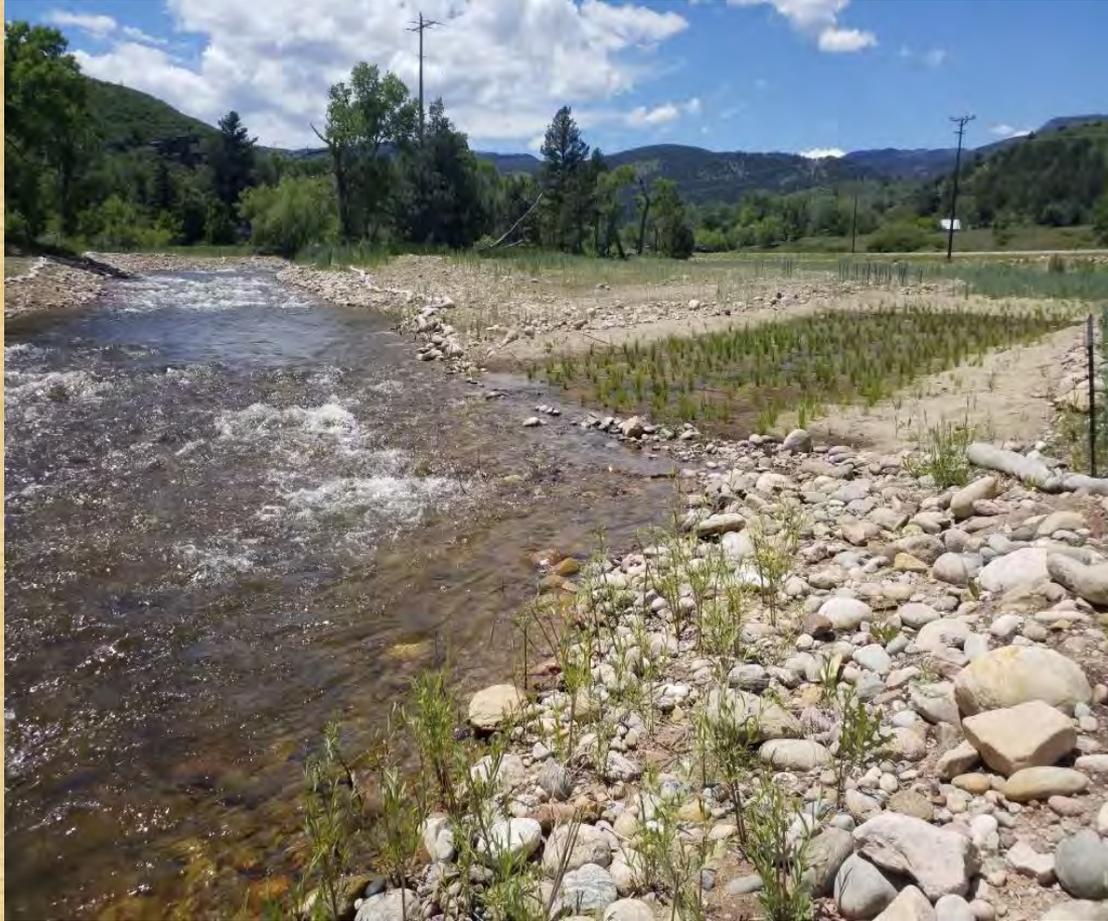
Progression of vegetation  
establishment

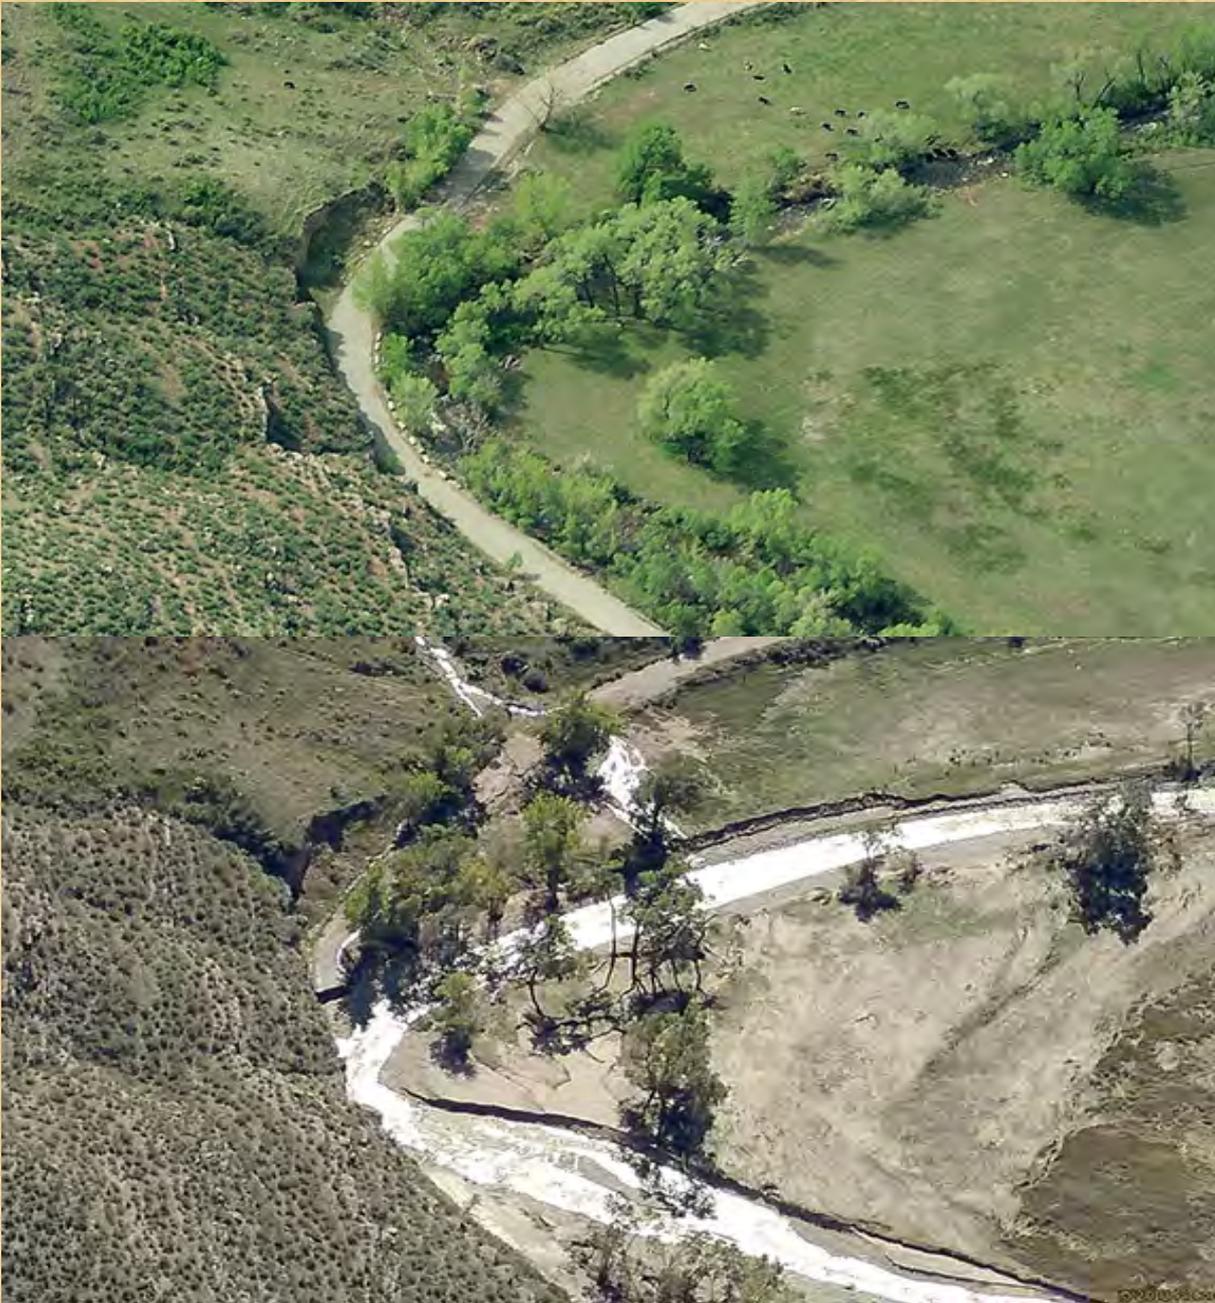
## Damage:

- volume of water
- velocity of water
- amount of sediment and debris

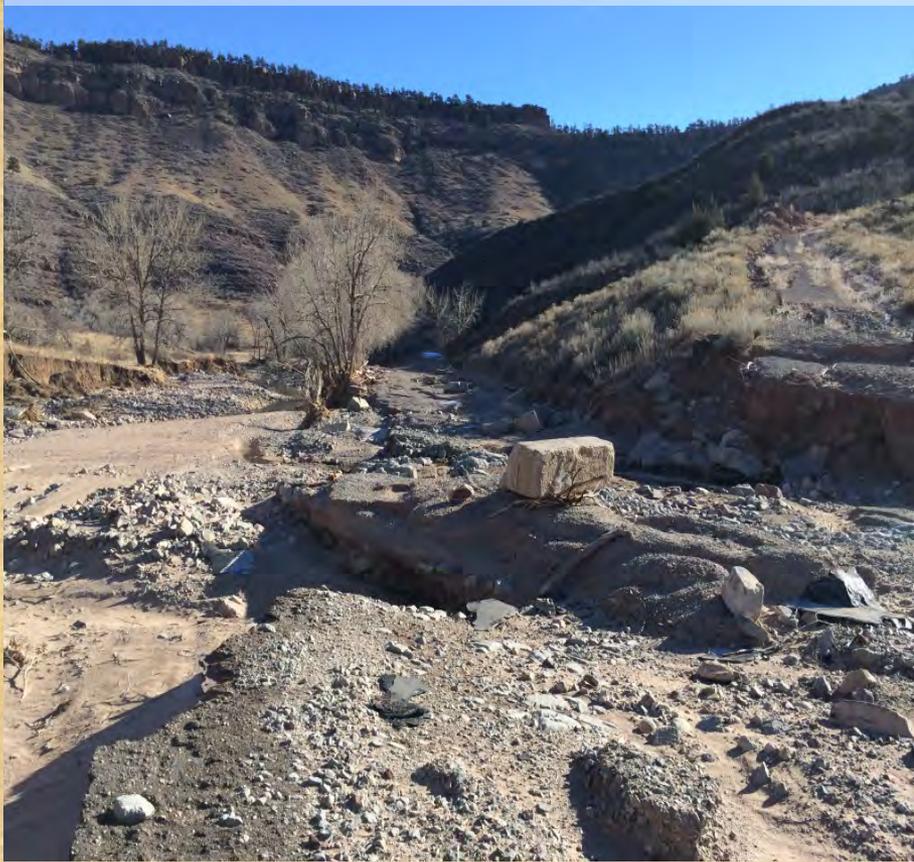
High concentrated flows damaged culverts, caused debris flows across the road and clogged roadside ditches.

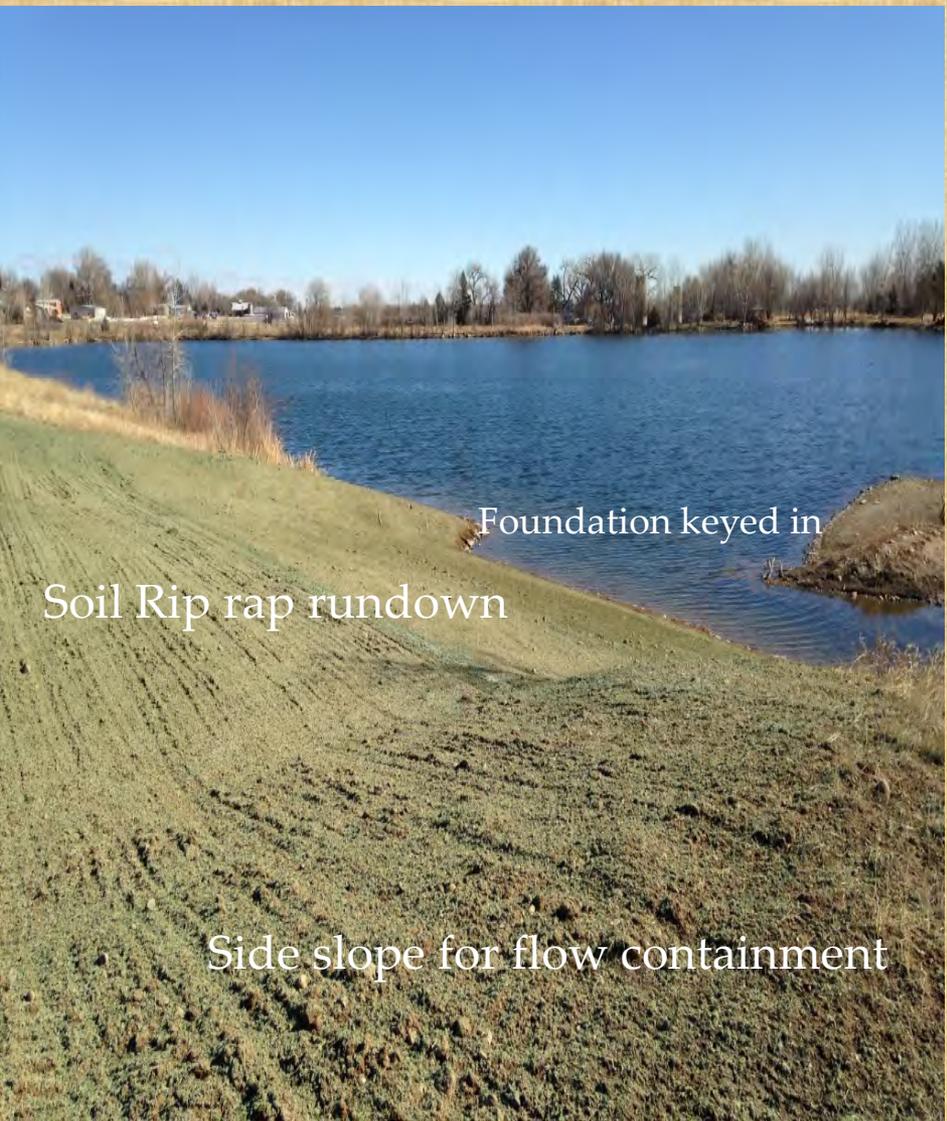
Full Breach

Foundation keyed in

Soil Rip rap rundown

Side slope for flow containment

Spillway

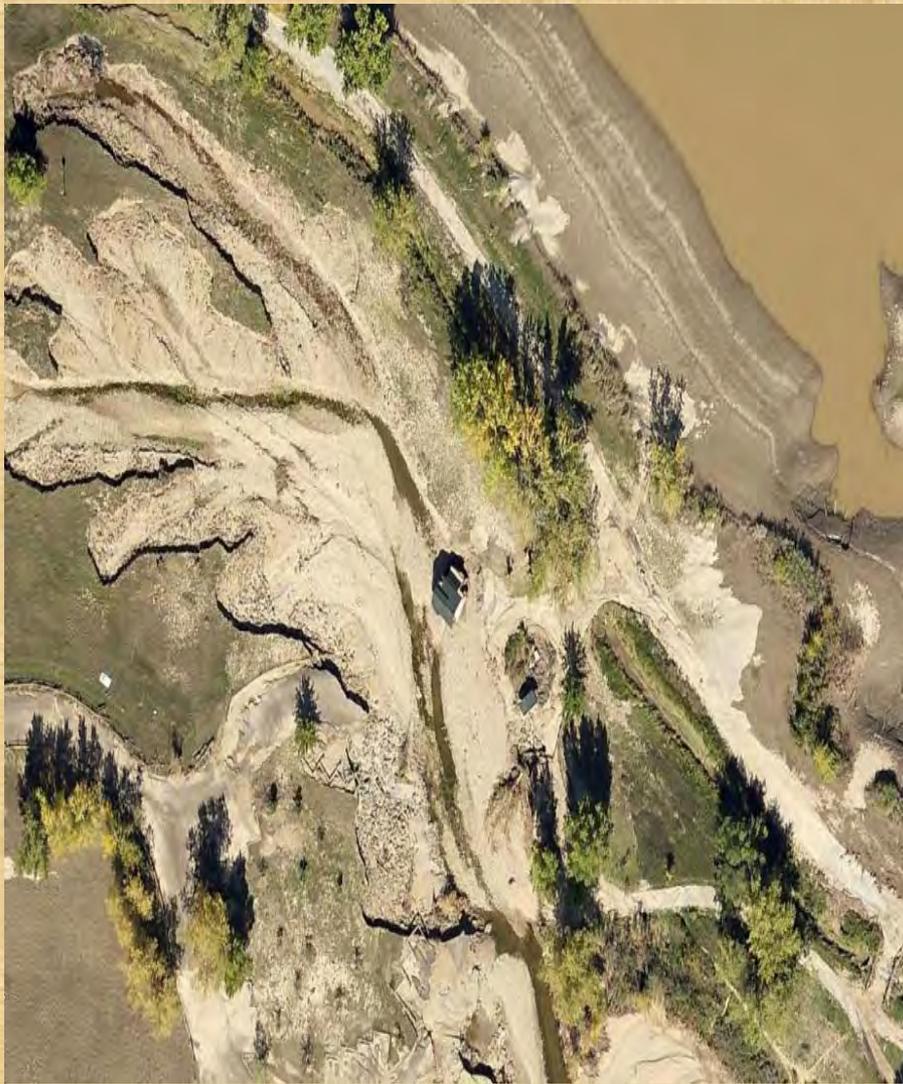
Heavy damage to trail head  
and parking lot

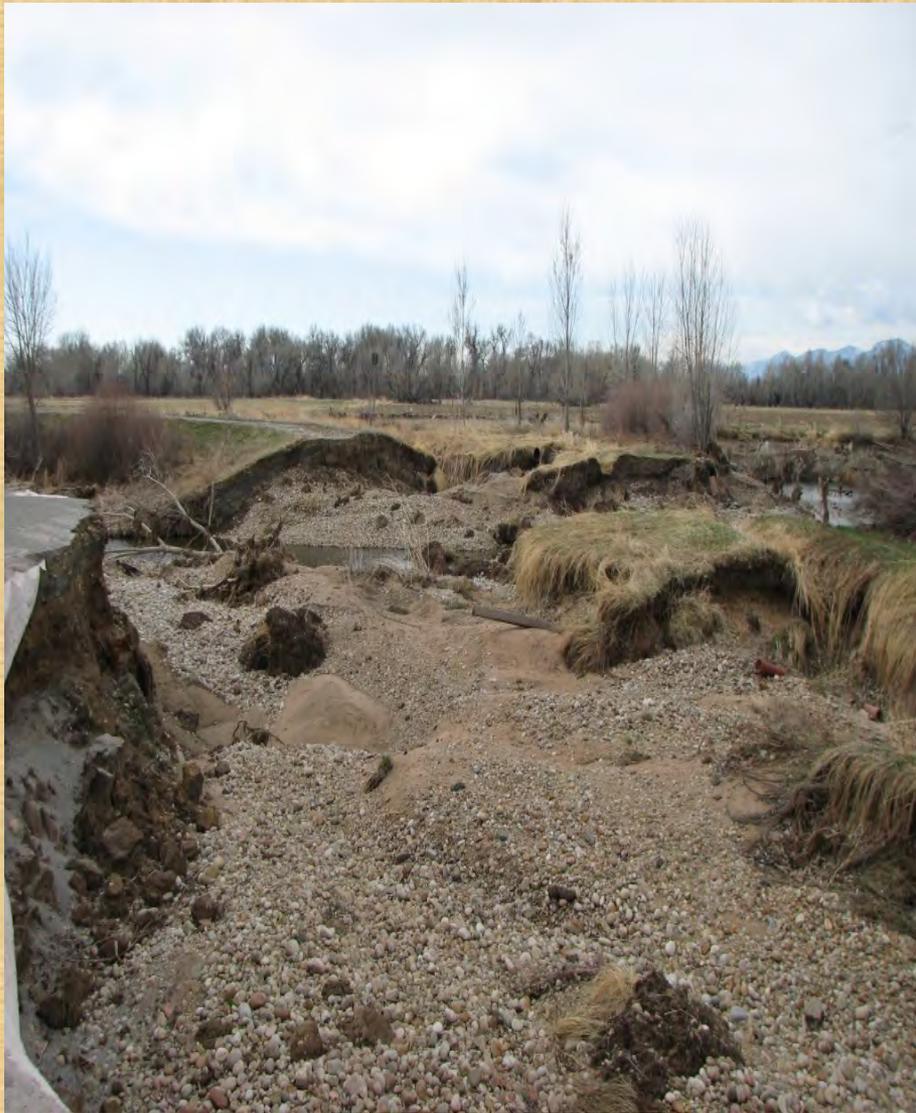
Full Breach
